NATIONAL DAM INSPECTION PROGRAM. SILVER STREAM RESERVOIR DAM (I--ETC(U)

REPORT DOCUMENTATION PAGE		READ INSTRUCTIONS BEFORE COMPLETING FORM
1. REPORT NUMBER	2. GOVT ACCESSION NO.	3. RECIPIENT'S CAT. LOG NUMBER
	AD A109900	
4. TITLE (and Subtitle) Phase I Inspection Report Silver Stream Reservoir Lower Hudson River Basin, Orange County, NY Inventory No. 511		5. TYPE OF REPORT & PERIOD COVERED Phase I Inspection Report National Dam Safety Program

**SILVER STREAM  
RESERVOIR DAM  
NY 00511**

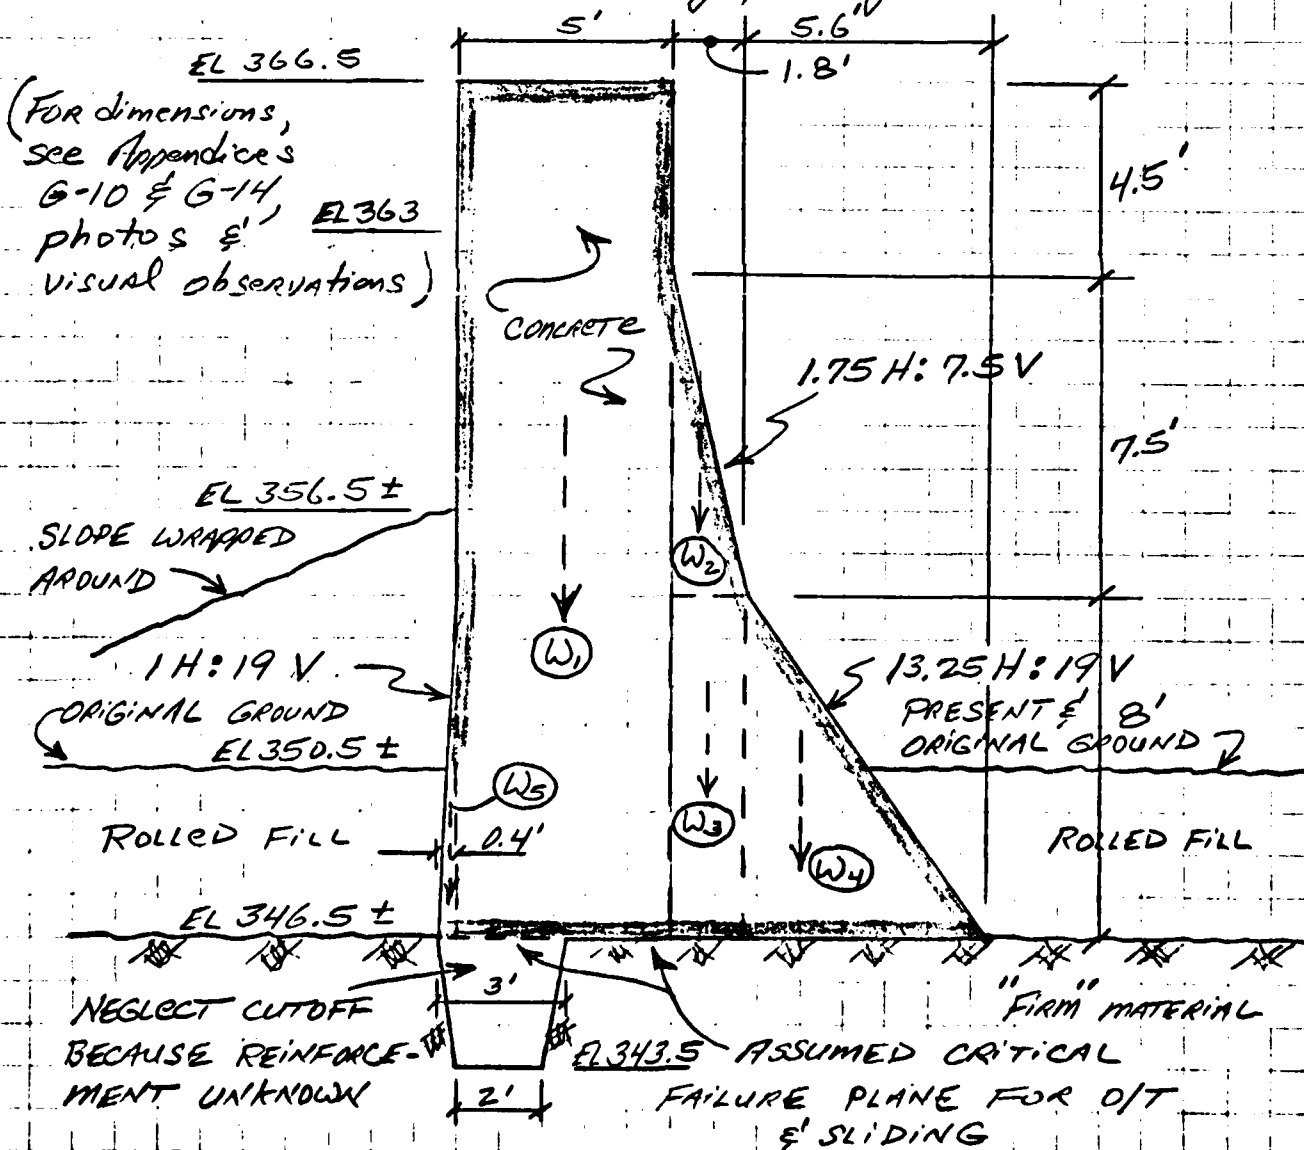
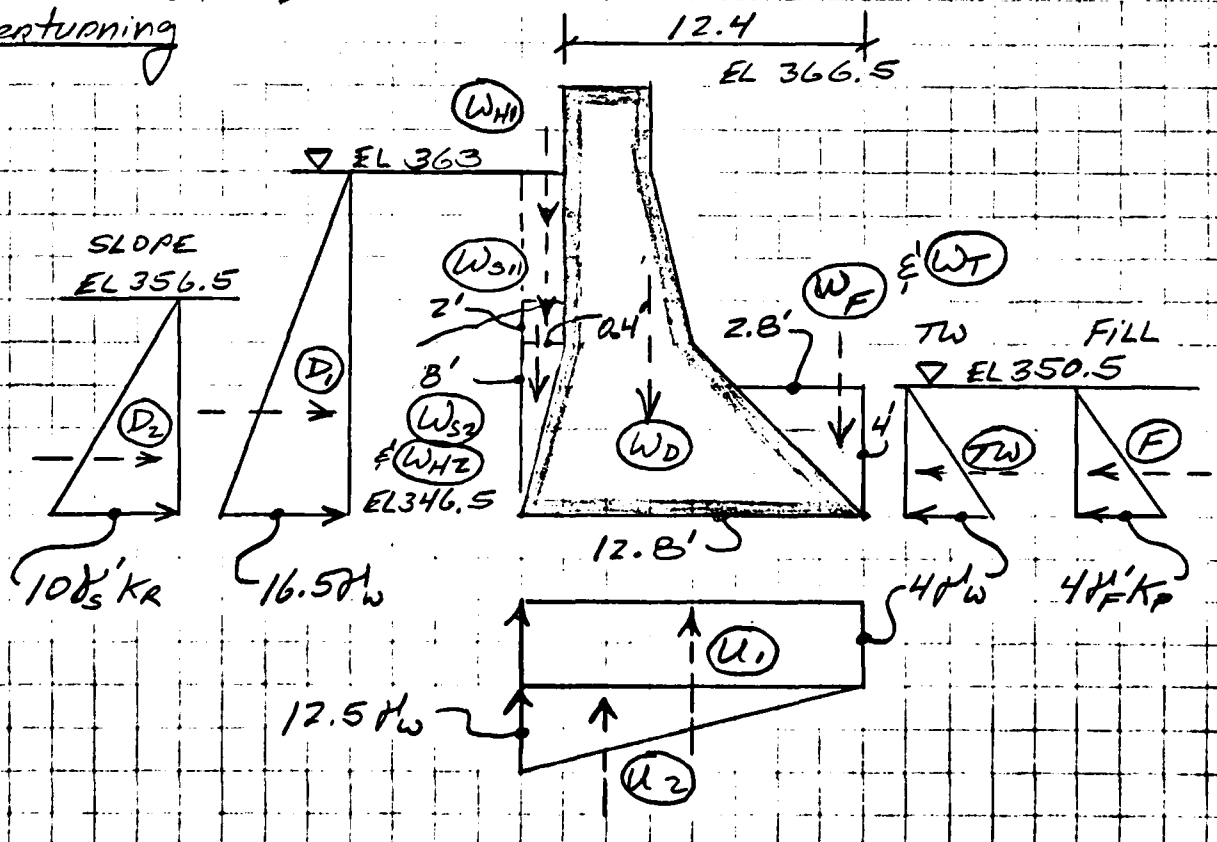
## STABILITY ANALYSIS OF CONCRETE DIKE

Structural stability analysis of the concrete dike indicates that it is unstable for the winter ice load and 1/2 PMF conditions and that it has unsatisfactory stability for the normal spring-summer-fall condition and the PMF condition. Therefore, it is recommended that a detailed structural stability analysis of the concrete dike under all loading conditions be started within 6 months after receipt of this report by the Owner. Any necessary remedial work should be completed within 18 months after receipt of this report by the Owner. The investigation and the design and construction observation of any remedial work should be done by a qualified, registered professional engineer.

CROSS SECTION FOR ANALYSIS - Just toward center from bend points where height exposed is large compared to height below ground and there is earth pressure on upstream side due to embankment wrapped around, but no earth pressure on downstream side above original ground.

CASE 1 Normal pool at spillway crest, full HW @ TW uplift, slope wrap around on U/S side about 10' below top by observation, TW at top of original ground by observation (due to ponded water)

- 7) Contingent on the results of the detailed structural stability analysis of the concrete dike, repair the cracking and deterioration of portions of the dike in accordance with design and field observation of the work by an engineer.
- 8) Prepare written routine operation and maintenance procedures for the dam, dike, and their appurtenances.
- 9) Institute a program of comprehensive technical inspection of the dam, dike, and their appurtenances by an engineer on a periodic basis of at least once every two years.
- 10) Develop an emergency plan outlining action to be taken to minimize the downstream effects of an emergency, together with an effective warning system. Also make provisions to open the outlet pipe valve, when necessary, to augment spillway flow during periods of heavy runoff.

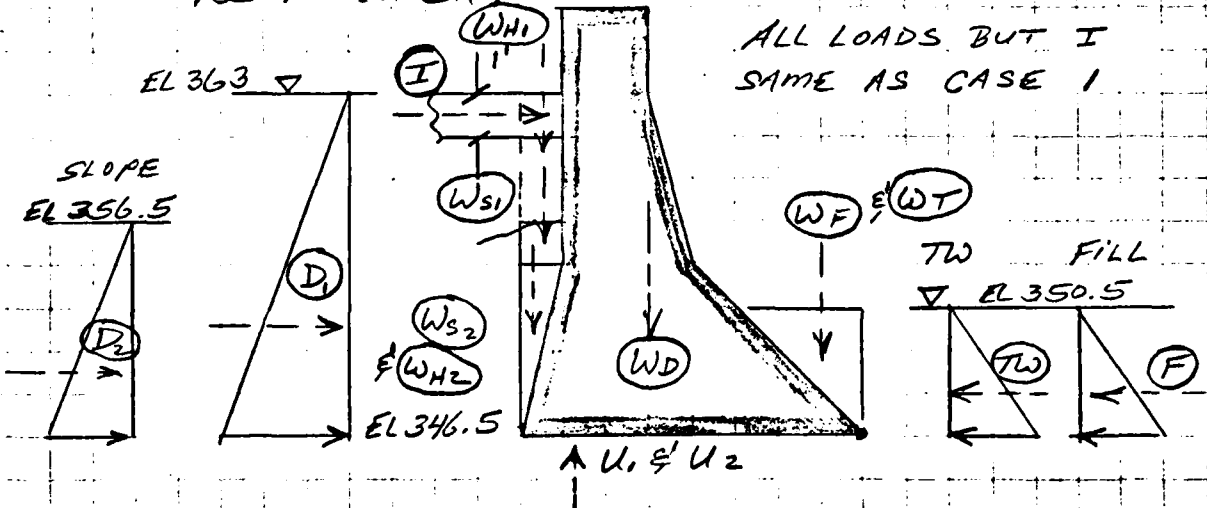
CASE 2 - Normal pool plus ice load of 5k/LF for ice 1' thick.

Resisting Forces  $\times$  Moment arm about toe =  $M_R$   
All same as Case 1, sheet 3  $\rightarrow \Sigma M_R = 196.02 \text{ Ftk}$

Driving Forces  
 $D_1, D_2, U_1, U_2$  same as Case 1, sheet 3 = 116.27  
 $I = \text{ice load} = 5k \times (16.5 - 0.5) = 80.00$   
 $\Sigma M_D = 196.27$

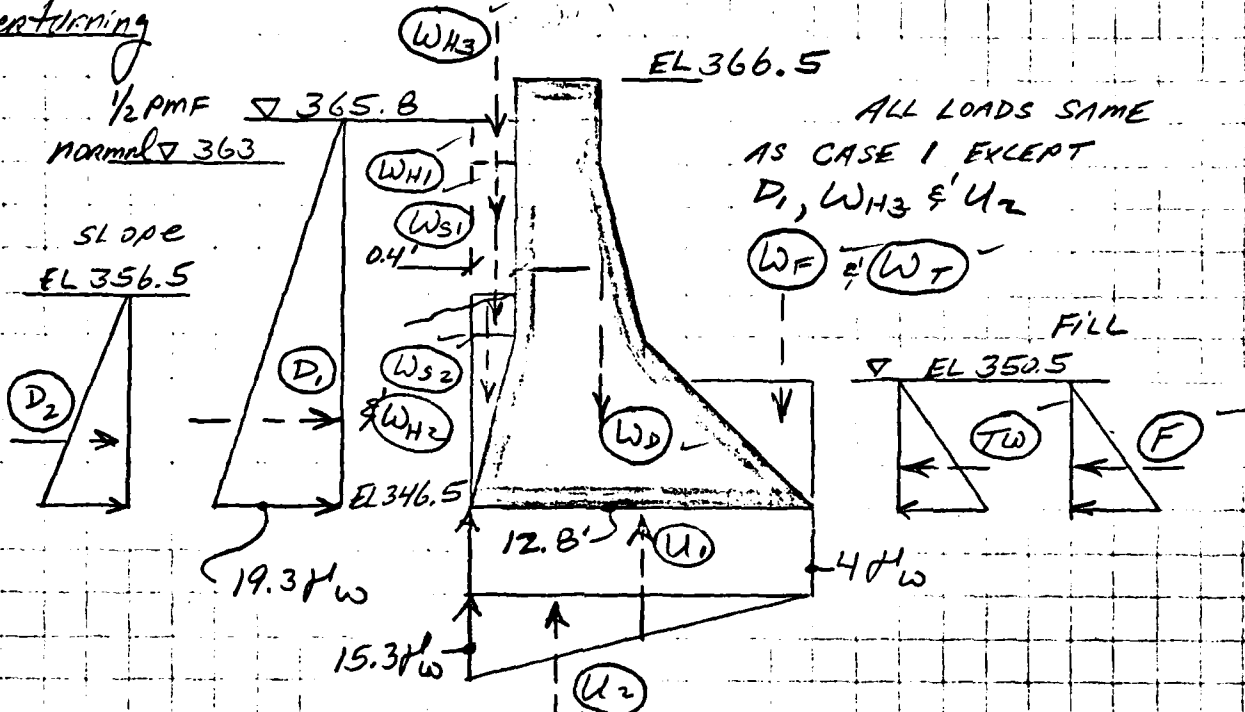
CASE 3 - 1/2 PMF pool full HW & TW uplift, remainder same as Case 1

Resisting Forces x Moment Arm about toe = MA  
 All except WH3 same as total for Case 1, sheet 3 = 196.02  
 WH3 = wt. of flood HW  
 =  $0.4 \times 2.8 \times 0.0624 = 0.07 \text{ k} \times (0.4/2) + 12.4 = \underline{12.47}$   
 $\Sigma M_R = \underline{196.90}$

Driving Forces x Moment Arm = MD  
 D2 = submerged slope press. same as Case 1, sheet 3 = 6.50  
 U1 = normal TW uplift = 20.45  
 U2 = flood HW uplift  
 =  $(1/2 \times 15.3 \times 0.0624) \times 12.8 = 6.11 \times 12.8 \times 2/3 = 52.14$   
 D1 = flood HW pressure  
 =  $(1/2 \times 19.3 \times 0.0624) \times 19.3 = 11.62 \times 19.3/3 = 74.77$   
 $\Sigma M_D = \underline{153.85}$

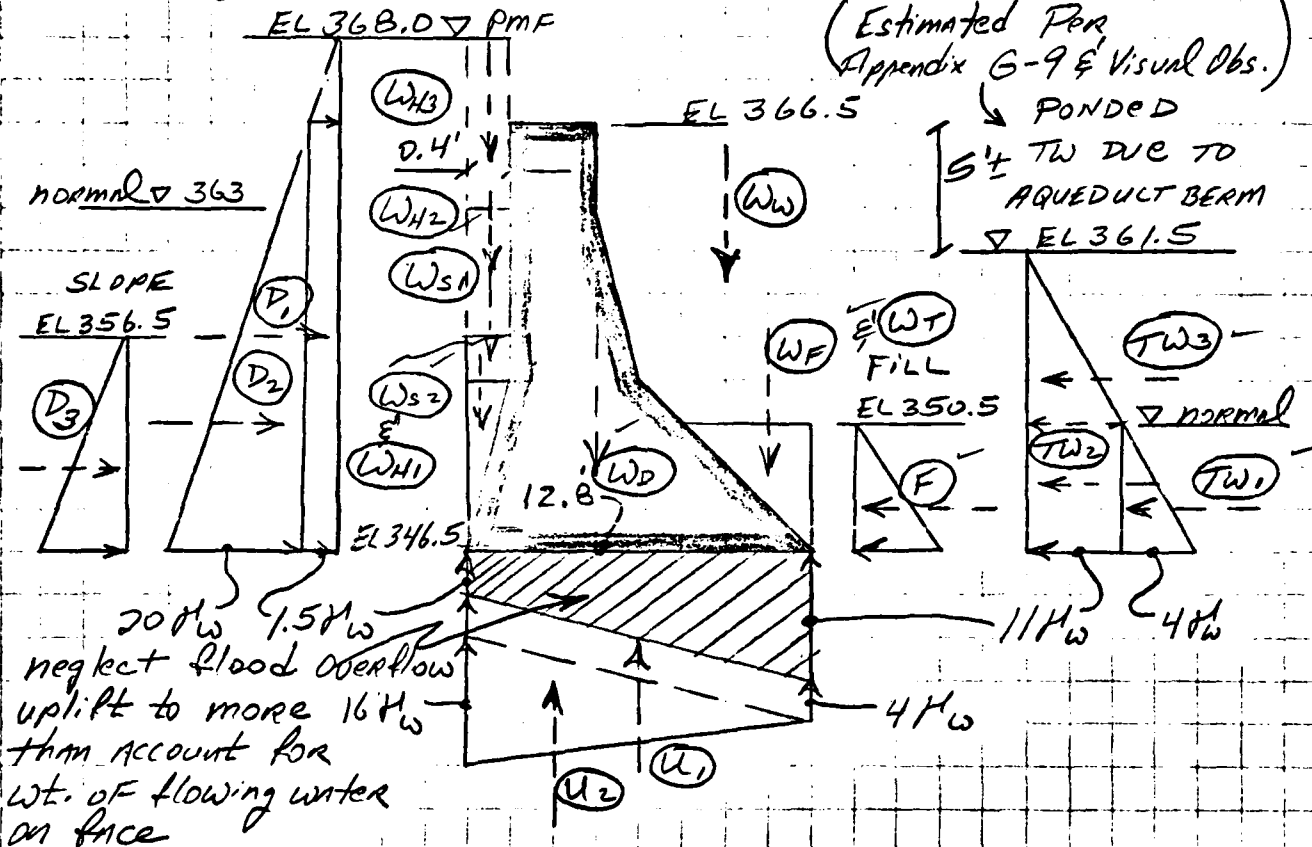
CASE 4 - PMF pool, full HW & TW uplift, remainder same as Case 1.

Hydrologic and hydraulic analysis indicates that the PMF overtops the dike, but not the dam embankment, even when the outlet pipe is fully open. The 1/2 PMF, however, does not overtop the dike, or the dam embankment which is 1.5 feet higher than the dike. Therefore, in accordance with Corps of Engineers design criteria for review of spillway adequacy, spillway capacity is considered "inadequate", but not seriously inadequate.
